Dublin San Ramon Services District	DATE JAN 2020
STANDARD DETAILS FOR PLACEMENT OF RECYCLED WATER IRRIGATION SIGNS	REVISED BD
SIGNED COPY ON FILE AT DISTRICT OFFICE	DRAWING W-28A

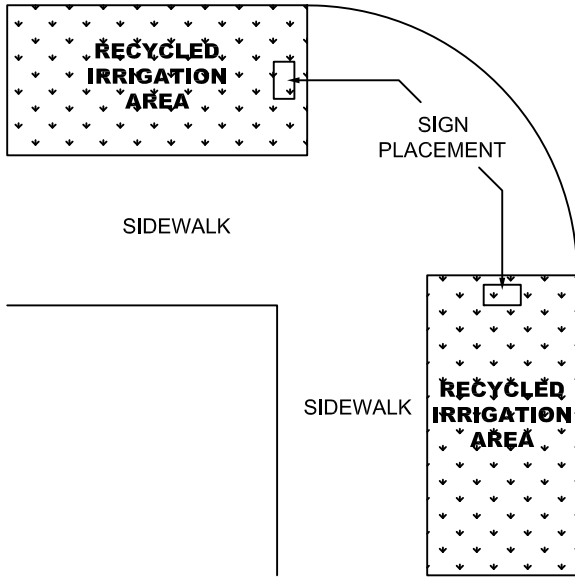
Fig. 1 Corner Pedestrian Crossing

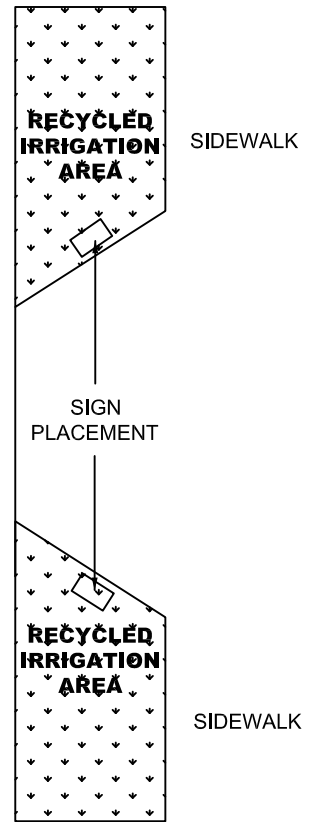
Fig. 2 MID-STREET PEDESTRIAN CROSSING

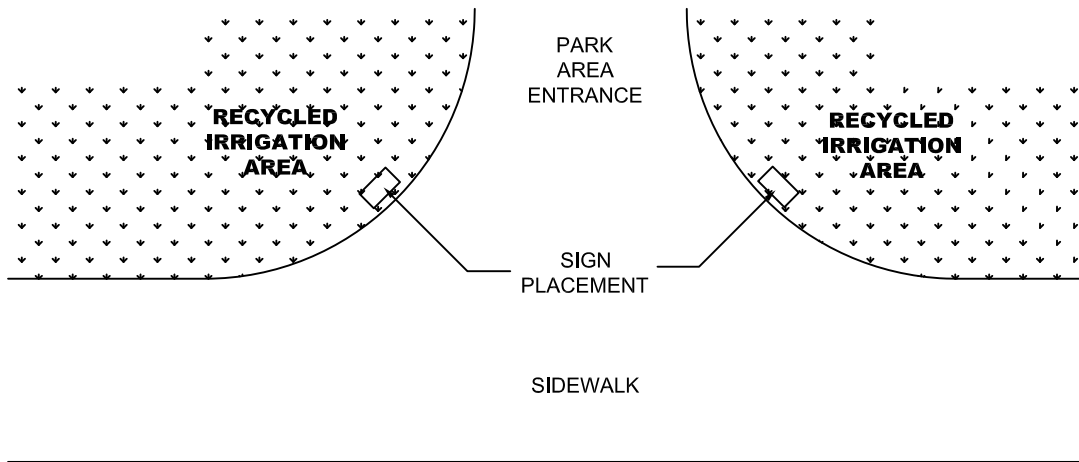
Fig. 3 PARK AREA ENTRANCE PLACEMENT
