Dublin San Ramon Services District	DATE DEC 2019
MANHOLE: FALSE BOTTOM	DESIGNED RM
SIGNED COPY ON FILE AT DISTRICT OFFICE	DRAWING S-16

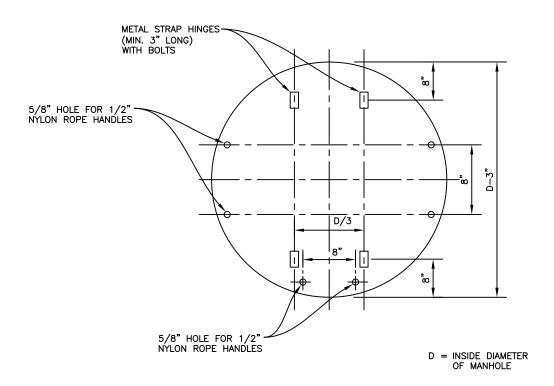
INSTALLATION AND REMOVAL POSITION NOT TO SCALE

FALSE MANHOLE BOTTOM SHALL BE REMOVED AFTER THE FINAL APPURTENANCE ADJUSTMENT INSPECTION. THE PAVING CONTRACTOR AND OWNER'S REPRESENTATIVE WILL COORDINATE THE REMOVAL OF THE FALSE MANHOLE BOTTOMS. CONTRACTOR SHALL REMOVE DEBRIS CAUGHT ON THE FALSE BOTTOM AND NOT ALLOW IT TO DROP INTO MANHOLE.
